MAZDA'S RECOMMENDED PROCEDURES FOR BYPASSING BATTERY SENSORS

An electrolyte level sensor was used on the 1979-81 Mazda 626 Coupe. This sensor is not compatible with replacement batteries, and therefore, must be bypassed when replacing the original equipment battery.

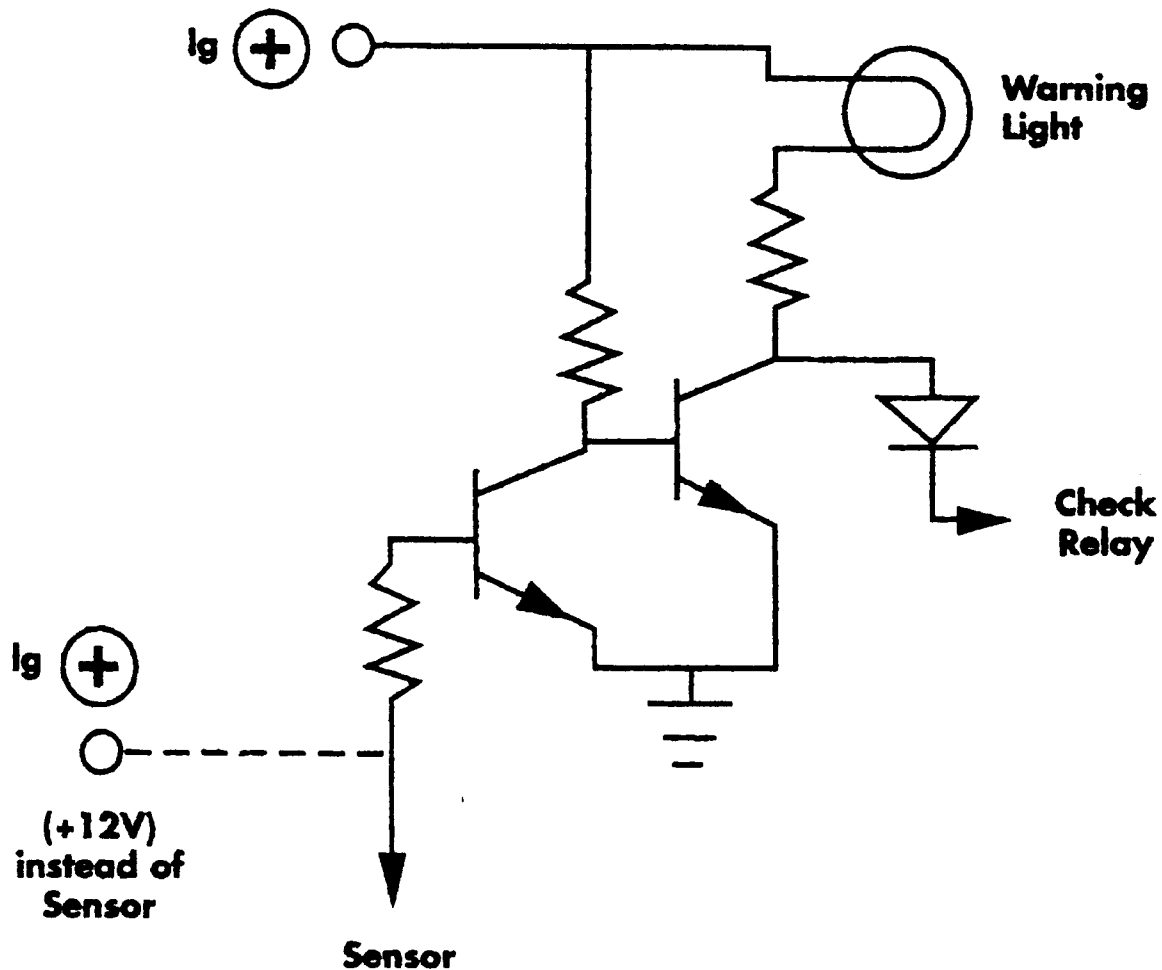
Make a suitable harness arrangement to supply voltage from the ignition switch to the sensor circuit so that the warning light does not come on. Note that the warning light only comes on when the circuit is open. (See circuit diagram.)

1. Fix the sensor harness to nearby main harness.
2. Remove the warning light bulb from the dash.

In other words, all that is necessary is to either remove the warning light bulb or to hook the circuit, up to 12 volts, via the ignition switch.
