# WELLS Counter Point

Volume 2 Issue 1, February 1998

## TPS Knowledge is Power

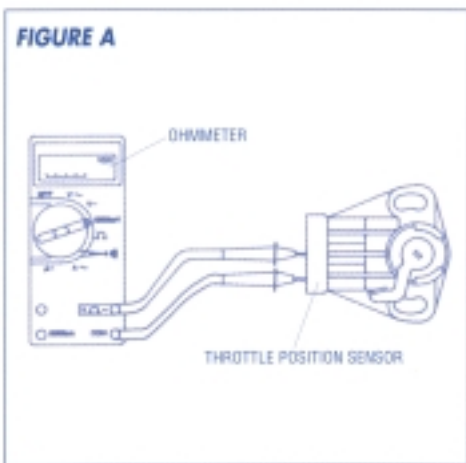
Here's a quick check you can use to check for a faulty TPS: First, with the engine and ignition off, unplug the electrical connector and attach an ohmmeter between the center terminal and one of the outer two terminals on the TPS. (See figure A) Manually operate the TPS by s-l-o-w-l-y opening the throttle. Note the ohmmeter reading. It should increase or decrease smoothly as you exercise the sensor through its full range of travel.

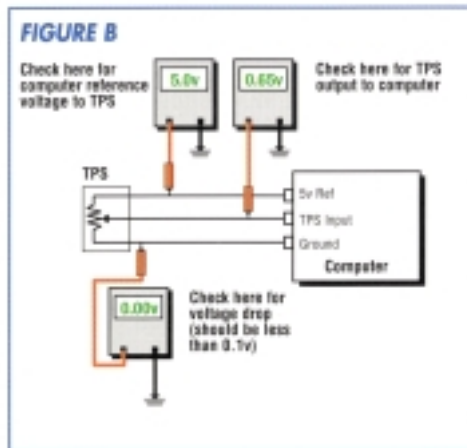
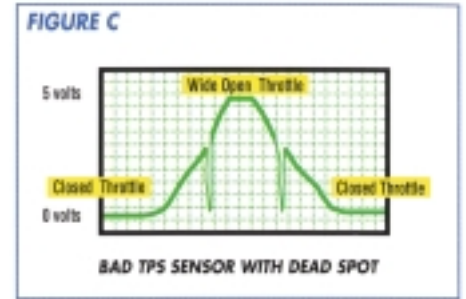
Erratic readings or momentary infinity (open) readings indicate a defective sensor. (See figures B and C) Full continuity (zero ohms) in either position would indicate a shorted sensor.

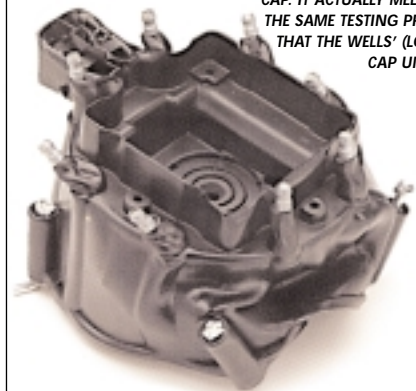
We found a competitor's cap that is made of materials that do not meet OEM specifications. The cap is for a popular GM application which requires a high temperature material such as "PBT" (polybutylene terephthalate). But this cap is made of "PP"

(polypropylene), which has a much lower melting temperature (350 degrees F vs. 482 degrees F for PBT). Though PP is often used for OEM distributor caps in other applications, it is not a suitable material for this particular application because it could fail under high-temperature operating conditions. It actually melted when subjected to the testing procedures that caps made by WELLS undergo, as the photo accompanying this article shown.

THIS IS A COMPETITOR'S DISTRIBUTOR CAP. IT ACTUALLY MELTED UNDER THE SAME TESTING PROCEDURES THAT THE WELLS' (LOWER LEFT) CAP UNDERWENT.

PBT, not PP. Consequently, because of differences in shrinkage rates, this cap had a slightly smaller inside diameter creating potential installation problems.
