Exhaust Gas Analysis – Part Two

Adding O₂ and CO₂ to exhaust gas analysis greatly increases your chances of diagnostic success.

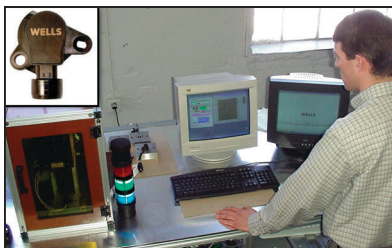
Next, the TP sensors are assembled, followed by a full function test of 100 percent of the completed sensors. The test is conducted on an innovative system designed by Wells engineers (shown here) and begins by mounting the TP sensor in a cradle that is exactly like the spot on the throttle housing where it will ultimately be mounted. One of the reasons we inspect 100 percent of our TP sensors in this way is to ensure a perfect fit.

Jason Strange checks the operation of the TPS tester. A laser-engraved TP sensor is in the inset.

The test system then fully sweeps the TP sensor twice to check for mechanical imperfections. The sensor is then slowly rotated through the full functional range, and the voltage slope is compared to OEM specifications stored in the adjoining computer. If the TP sensor passes these tests, a laser prints the Wells logo, part number, date code and serial number on the sensor face.
